Sidewall Repair

This process describes the safe and proper procedure to repair any unit which experiences a crack at the bottom corner of a slideout at the gooseneck of a 5th wheel, opening the side wall to repair broken tube welds. This technical service bulletin explains how to perform the repair. Please note: A sublet will be required for aluminum welding if you do not have that capability.

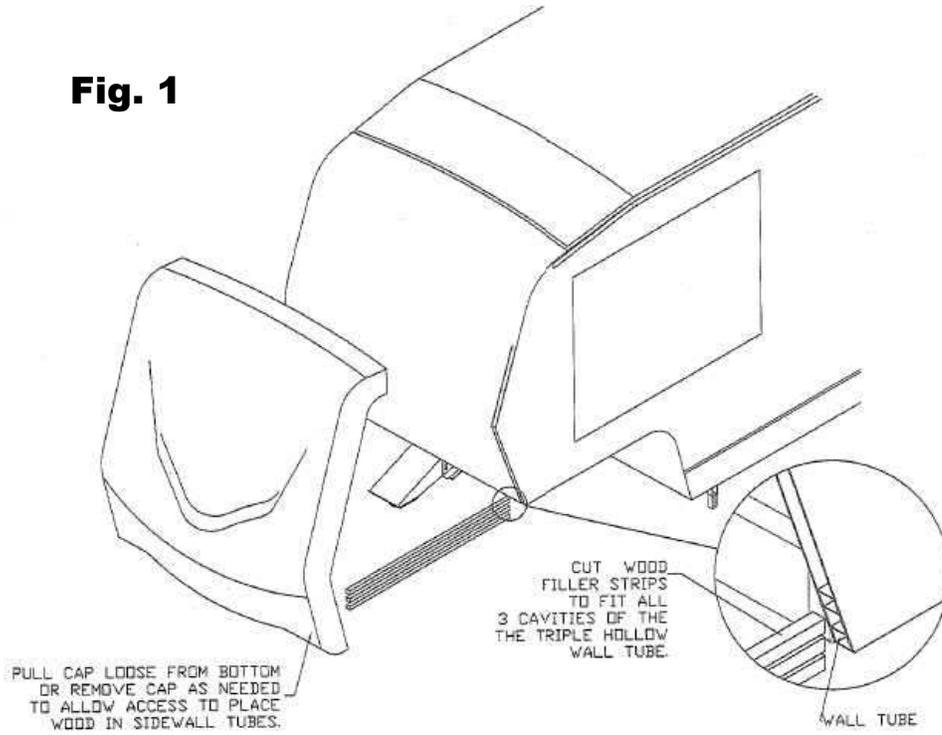
Fig. 1

Remove front cap and bed slide box. Remove roof line molding and peel back roof materials. Remove molding around slide opening and gooseneck edge of sidewall. Remove molding used to cover expansion joint/relief cut at bottom of slideout opening. Cut skin within 1" of top slideout corner from slide opening to roof line.

If wood is missing in tubes, see Figures 1 and 2.

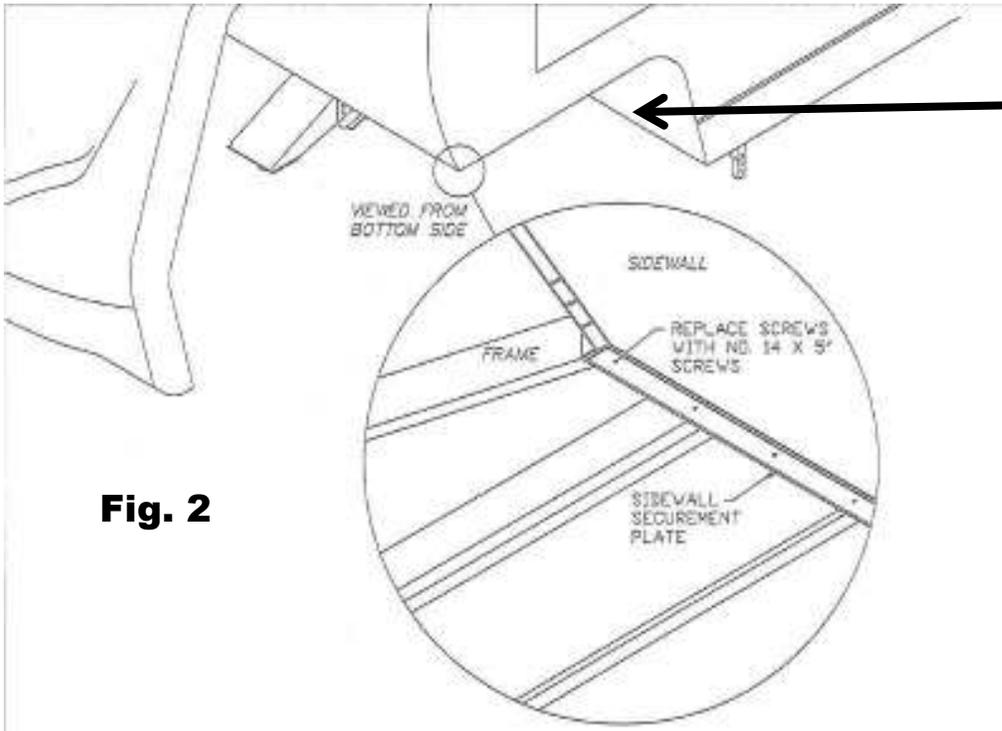
Fig. 2

If wood is present in all tubes, continue to replace the screws as directed in Figure 2.

In Figure 2 replace screws all the way to this point.

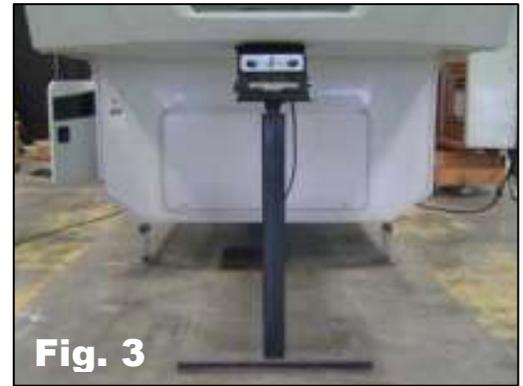
Fig. 3

VERY IMPORTANT! PLACE HITCH WEIGHT ON PIN, THEN LOWER FRONT LANDING LEGS TILL THEY TOUCH THE GROUND BUT DO NOT RAISE THE UNIT. LEAVE WEIGHT ON PIN FRAME THROUGHOUT REPAIR. SEE FIGURE 3

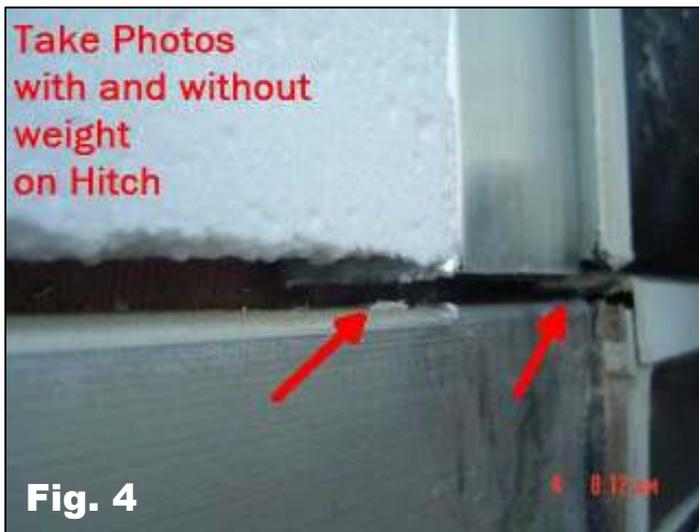
Fig. 4

Inspect lower and upper welds for cracks. Take photos of all cracked/broken welds with weight on the hitch, see Figure 4.

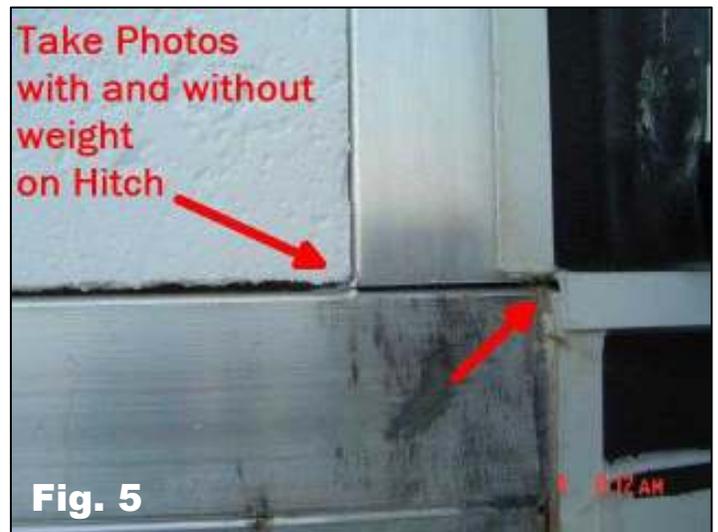
Fig. 5

Take photos with weight off the hitch, see Figure 5.

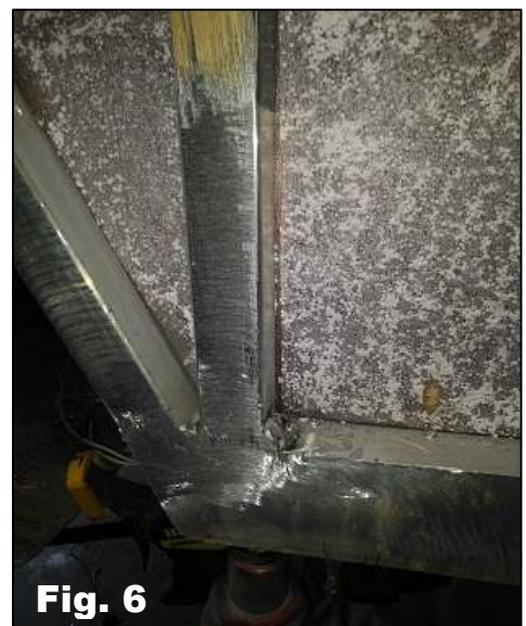
Fig. 6

Repair all broken/cracked joints as needed and add gussets, if you don't have anyone that does aluminum welding contact a local welder and sublet to repair tubes, see Figure 6 and 7.

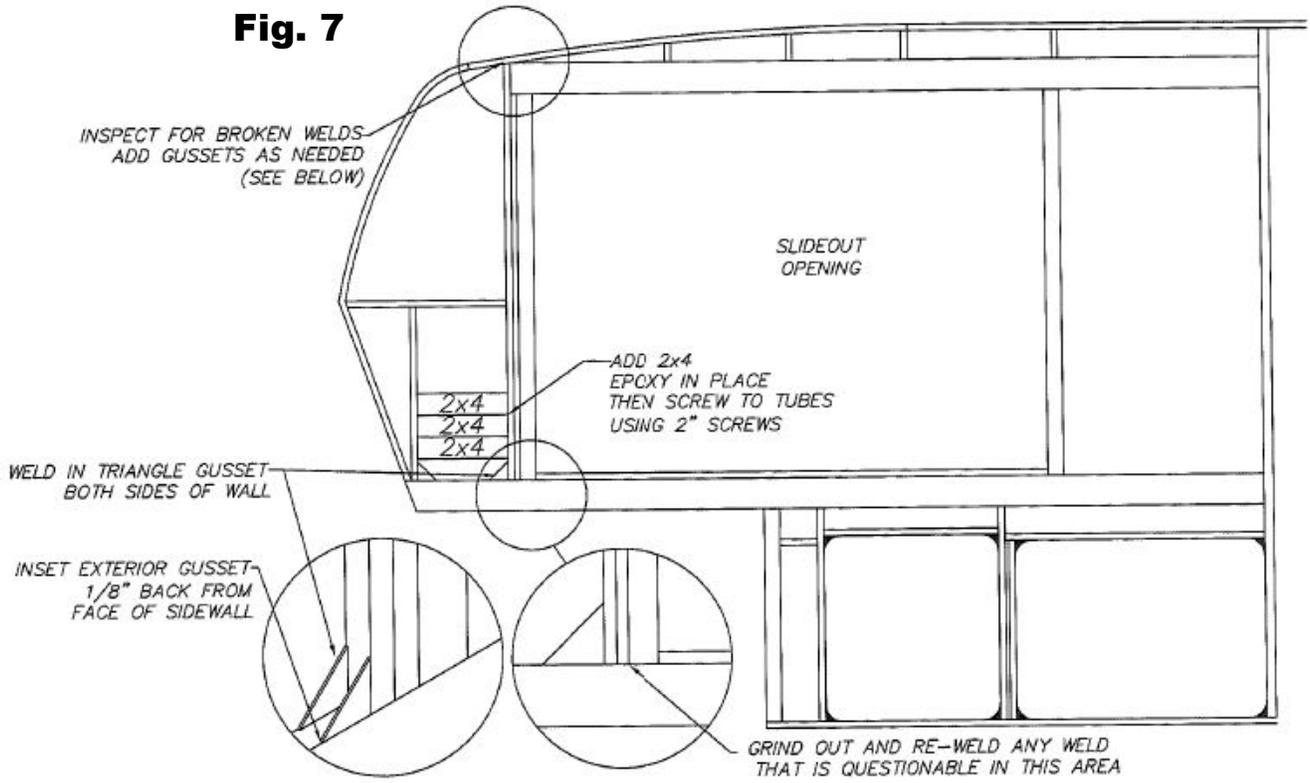
Fig. 7

Dig out the foam between the aluminum studs, clean area to accept adhesive and reinforcement wood. Cut 2x4's or 2x6's to fill area between 2 aluminum studs. Using the adhesive KRV # 207257 install the studs to the interior paneling, use 2" screws to secure aluminum studs as shown in Figures 7 and 8.

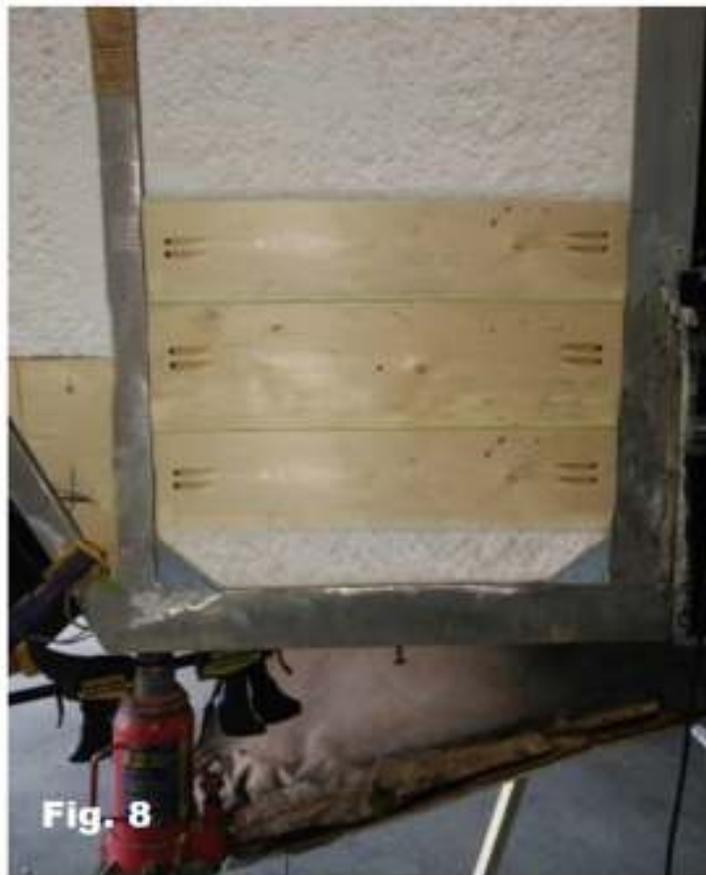
Clean surface of tubes with scraper and grinder, and then prep tubes with alcohol or similar. Scuff tubes with sandpaper to accept adhesive, see Figure 8.

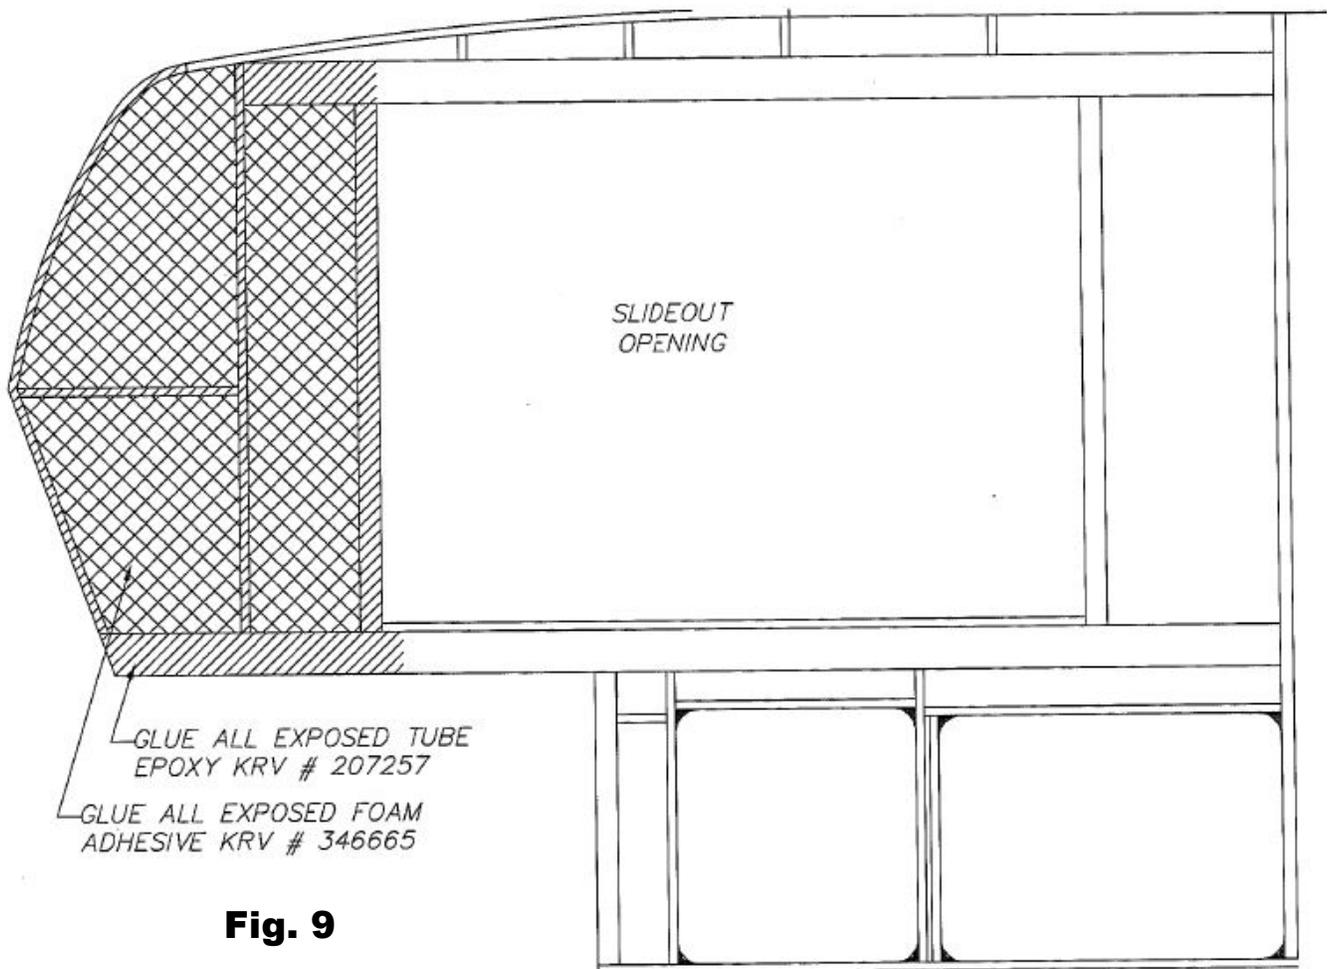
**Fig. 9**

Following the directions of the Adhesive, apply KRV # 207257 Panel Bonding Adhesive liberally onto tubes in exposed areas where fiberglass was removed. Use tool/squeegee to cover all exposed tubes, see Figure 9.

Following the directions of the Adhesive, apply KRV# 346665 Adhesive - Sealant liberally to the exposed foam and wood, squeegee to evenly distribute, see Figure 9.

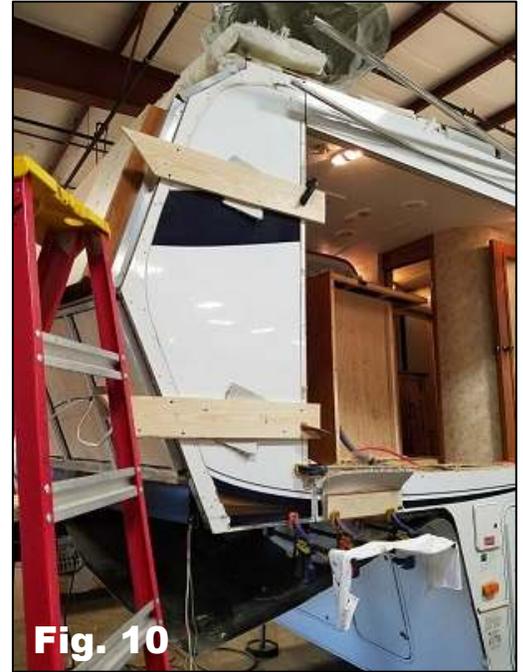
Fig. 10

Clamp new skin to surface with clamps and a board and let set for 8 hours, see Figure 10.

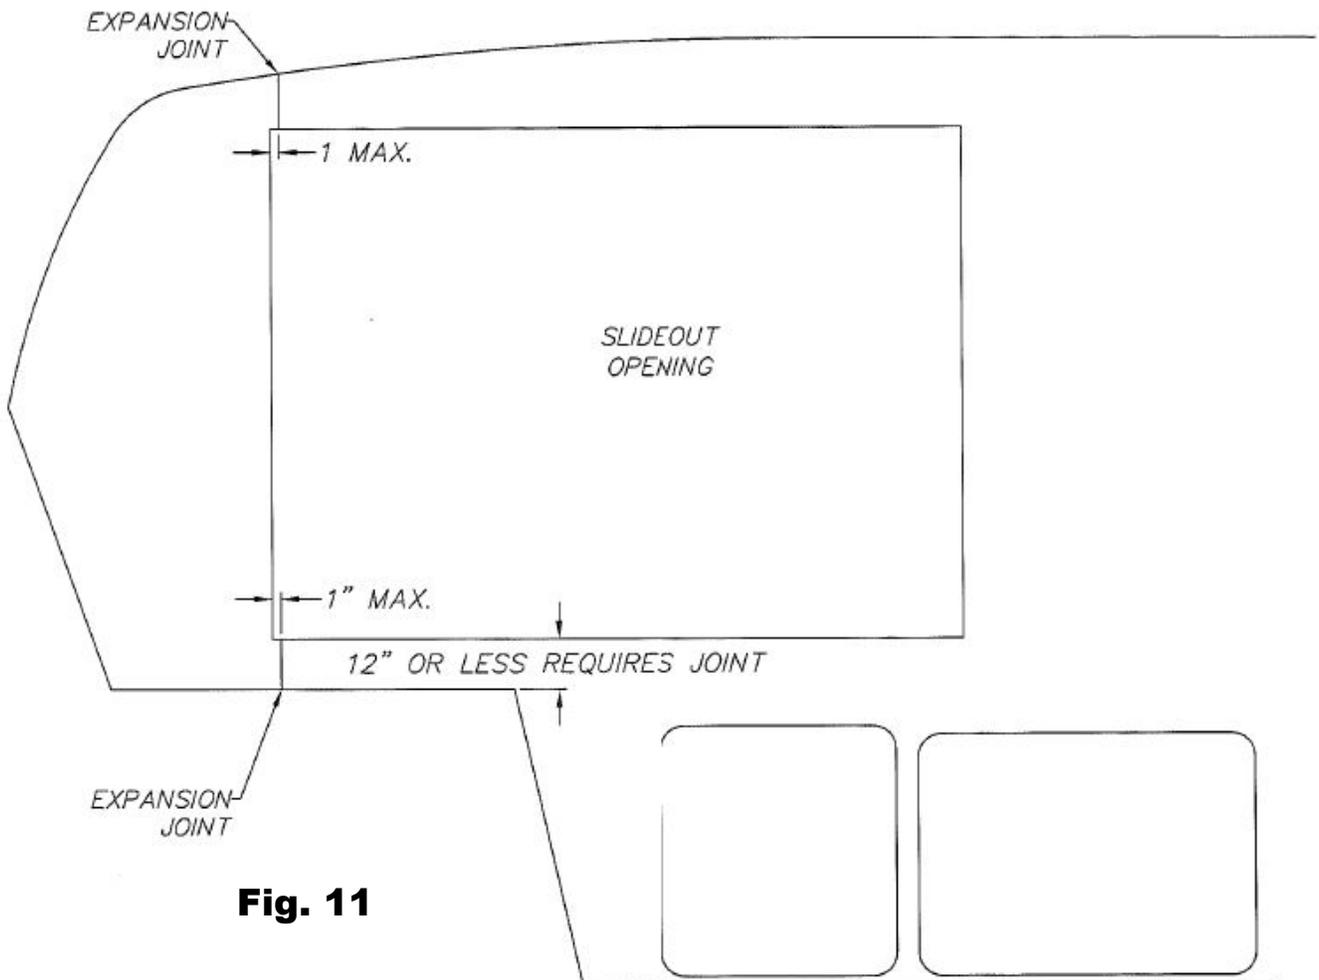
Fig. 11

If expansion joint/relief cut is not within 1" of slideout opening, perform fiberglass repair to existing cut, then cut-in new expansion joint/relief cut. Refer to diagram below for proper placement of expansion joint/relief cut. Another expansion joint will need to be added at the top, see Figure 11.
